**NASA TM X-71734**

**HOT CORROSION EVALUATION OF ALUMINIDE COATED SUPERALLOYS  
IN SUPPORT OF AN ASTM ROUND ROBIN PROGRAM**

by Gilbert Santoro  
Lewis Research Center  
Cleveland, Ohio 44135  
July, 1975

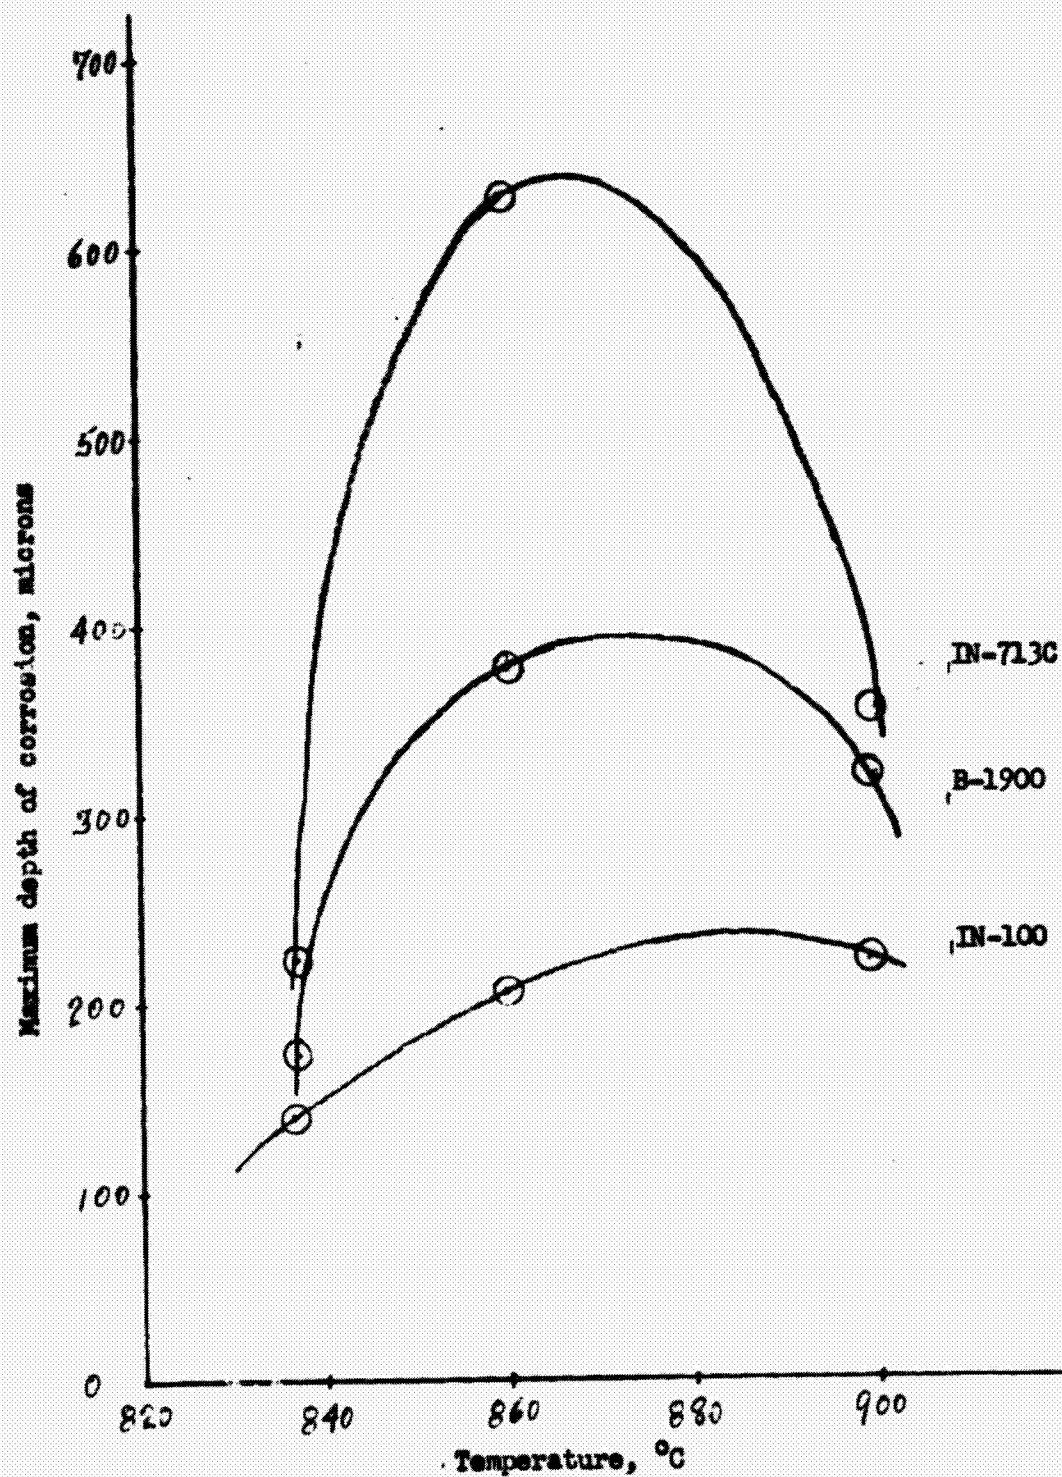
Figure 5. - Corrosion of uncoated alloys in the 0.3 mach burner rig after 40 hours exposure to 5ppm synthetic sea salt and with 10 minute cycles.

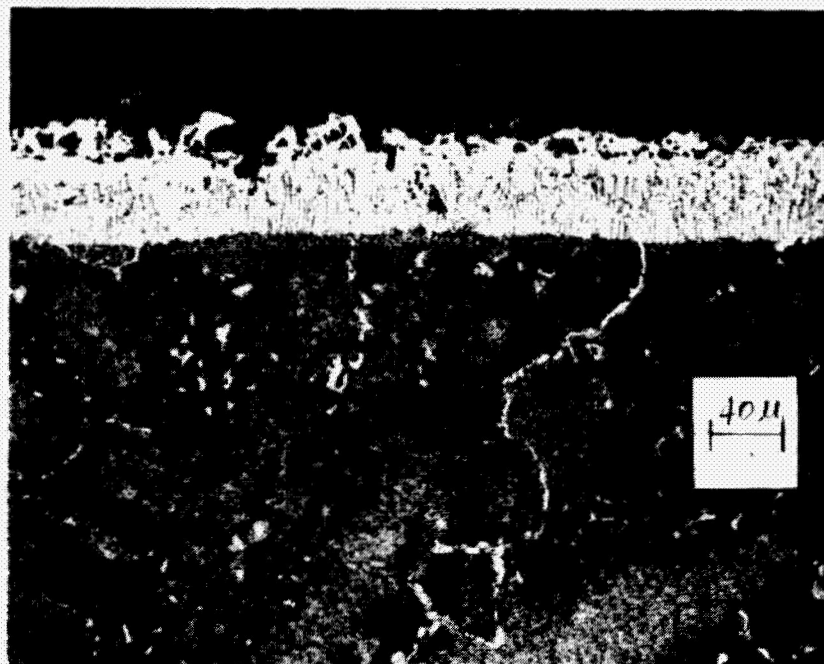
(a) IN-713C Coating A hot zone. Corroded 900°C, 70 hours, 10 minute cycles.

Figure 7. - Microstructure of the corroded coatings showing the oxide scale, coating proper, diffusion layer, and the substrate.

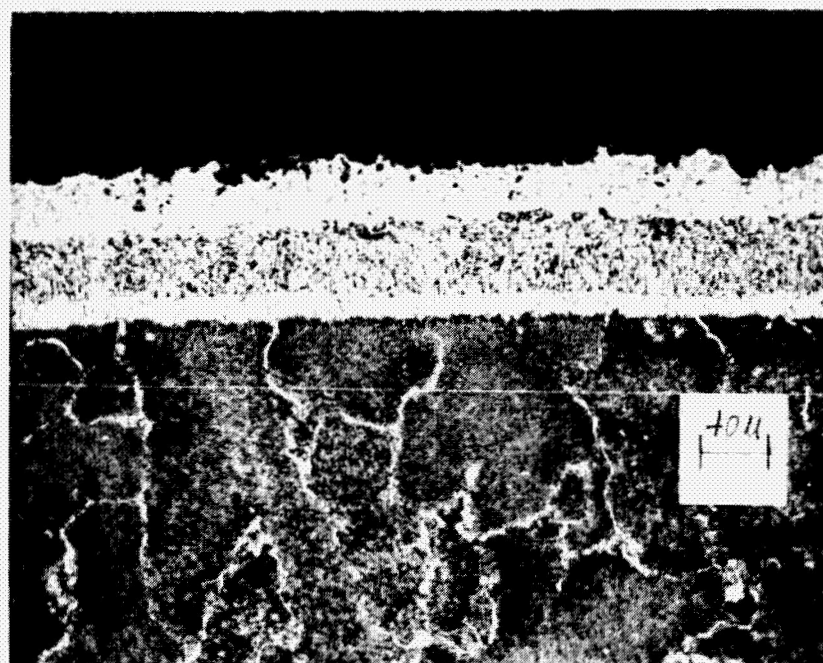
(b) IN-713C Coating B hot zone. Corroded 900°C, 55 hours, 10 minute cycles.

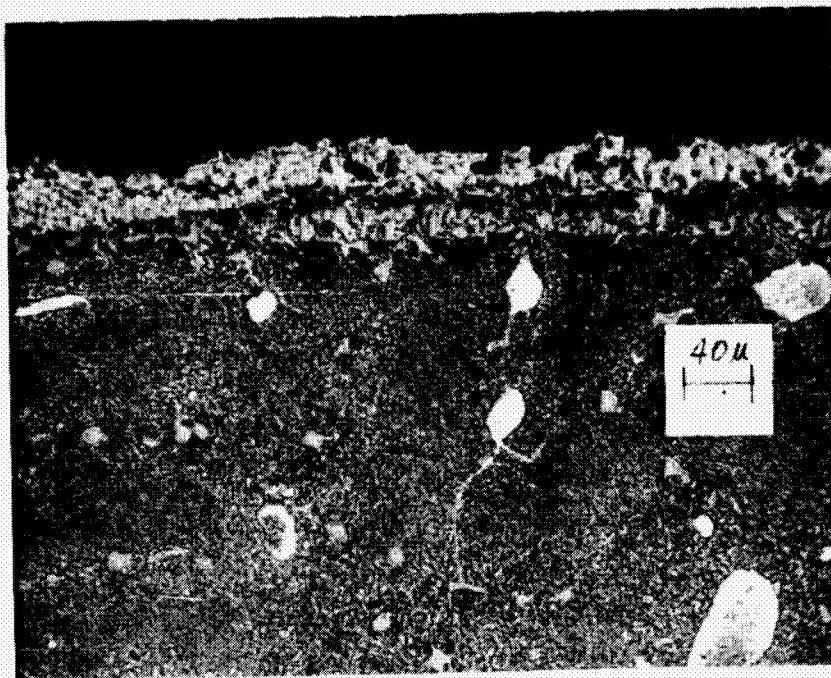
(c) IN-100 Coating A hot zone. Corroded  
900°C, 40 hours, 10 minute cycles.

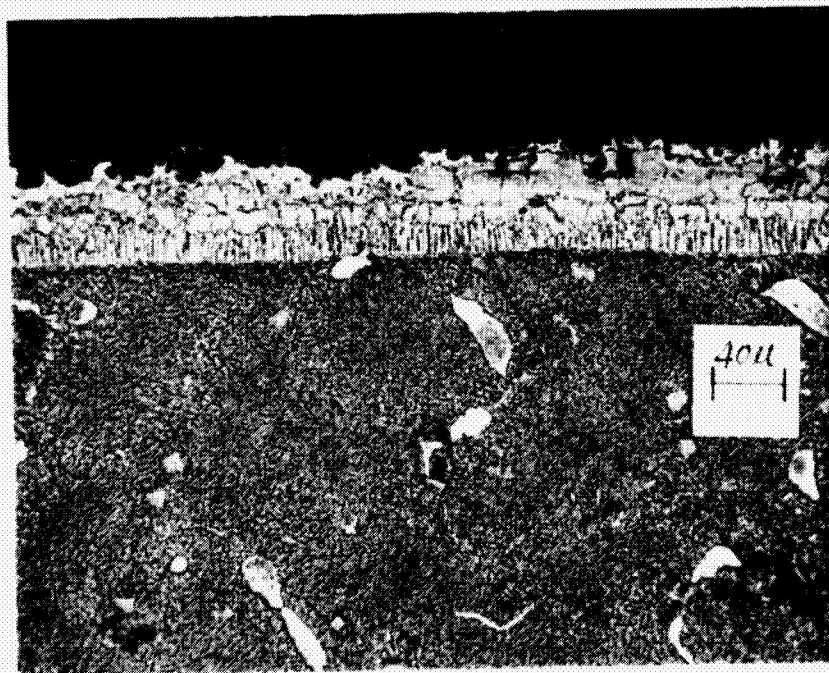
(d) IN-100 Coating B hot zone. Corroded  
900°C, 45 hours, 10 minute cycles.

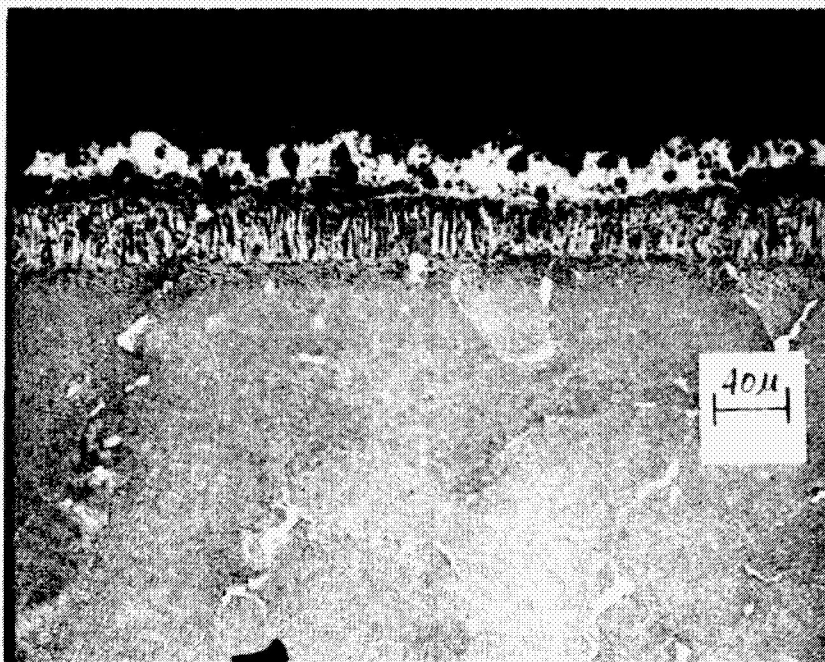
(e) B-1900 Coating A hot zone. Corroded  
900°C, 55 hours, 10 minute cycles.

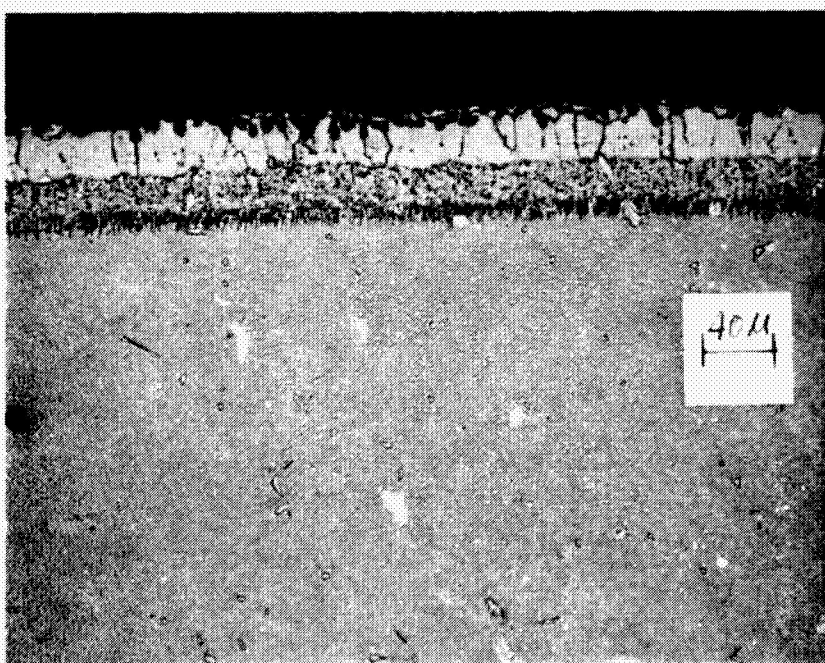
(f) B-1900 Coating B hot zone. Corroded  
900°C, 40 hours, 10 minute cycles.

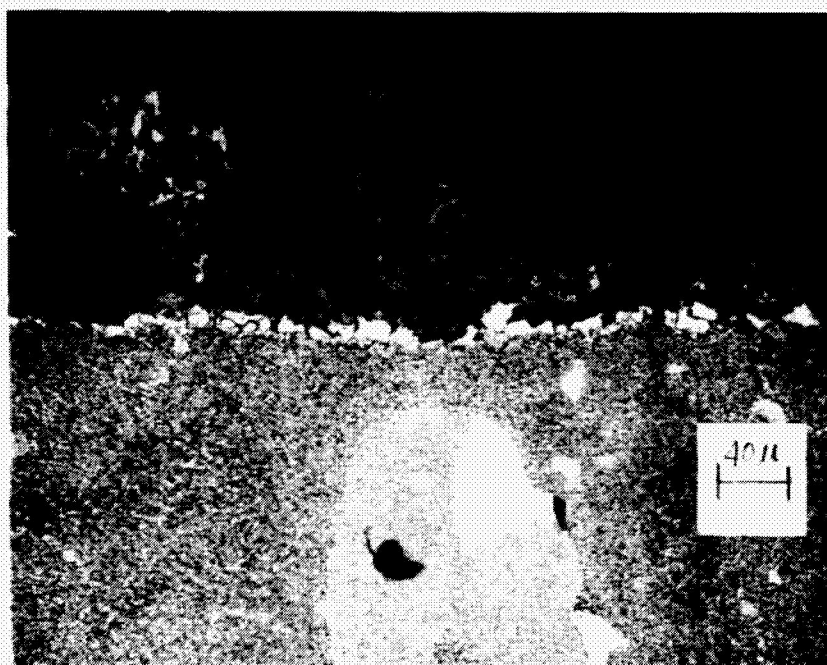
Figure 9. - Microstructure of a corrosion pit in EI-100 coating A.

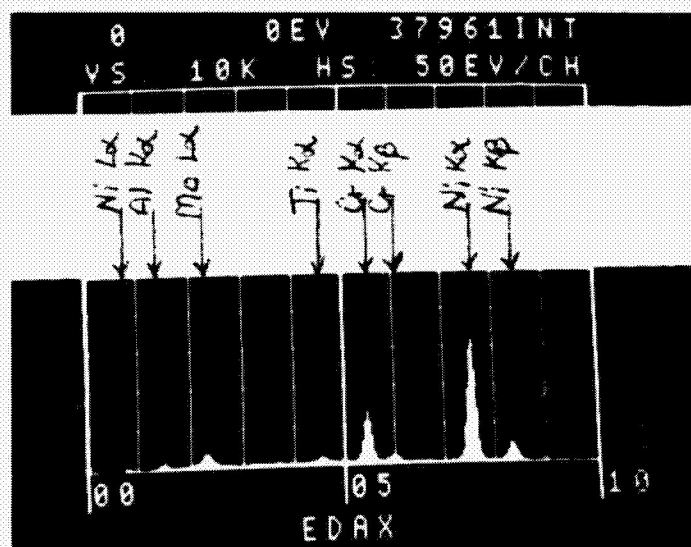
long diagonal cracks. The energy dispersive x-ray spectrum provision of the SEM and raster scans from the electron probe reveal a depletion of the Al and Cr concentration in what is left of the coating after corrosion. This depletion was observed in the coating proper and in the diffusion zone and accounts for the change in the morphology of the coating noted above. The distribution of the elements in the substrate just below the diffusion zone was not altered. A comparison of figure 9 with figure 2(c) provides an example of the depletion within the diffusion zone, particularly of the Cr. The distribution of sulfur in the corroded specimens is also of interest. This element was detected in the scale near the scale-coating interface and throughout the coating proper but not in the diffusion zone. It was found by raster scan to exist in clumps rather than being uniformly distributed. Figure 10 is an example of the sulfur distribution.

Figure 9.- Energy dispersive x-ray spectrum for elements in the diffusion layer of coating A on DI-713C, corroded at 900°C, ten minute cycles.

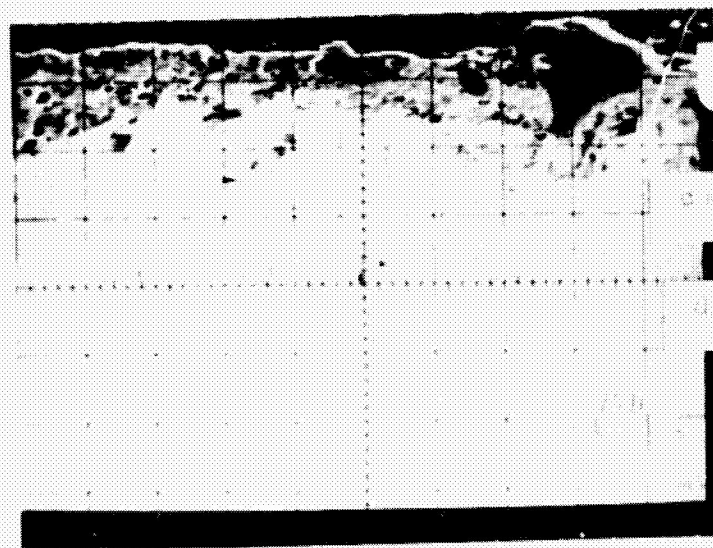
(a) electron micrograph of EN-713C Coating A.  
Corroded 200°C, 10 minute cycles.

(b) Raster scan of S<sub>Kα</sub> on area shown in (a),  
somewhat shifted to the left.

Figure 10. - Sulfur distribution in Coating A on EN-713C showing the sulfur distributed  
in clumps in the scale and the coating proper but not in the coating's diffusion zone.
